## PIC18F66K80 Family Silicon Errata and Data Sheet Clarification

The PIC18F66K80 family devices that you have received conform functionally to the current Device Data Sheet (DS39977F), except for the anomalies described in this document.

**Note:** This document summarizes all silicon errata issues from all revisions of silicon, previous as well as current. Only the issues indicated in the last column of [Table 2](#) apply to the current silicon revision (A6).

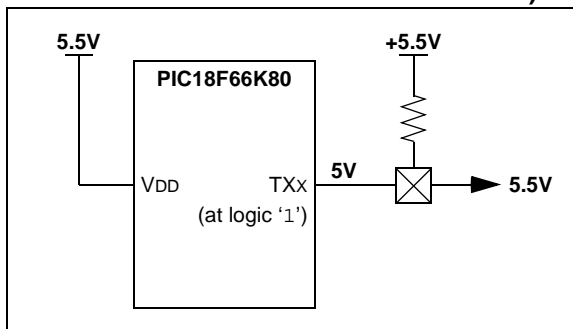
**FIGURE 11-2: USING THE OPEN-DRAIN OUTPUT (USARTx SHOWN AS EXAMPLE)**

The output pins for several peripherals are also equipped with a configurable, open-drain output option. **This allows the peripherals to communicate with external pull-up voltage.**

**When the open-drain option is required, the output pin must also be tied through an external pull-up resistor provided by the user.**

Figure 11-2: Using the Open-Drain Output (Usart Shown as Example) on page 173 should be as follows:
